Plug Power, Inc.

Final Project Report – FY02 PEM Fuel Cell Demonstration

Proton Exchange Membrane (PEM) Fuel Cell Demonstration
Of Domestically Produced PEM Fuel Cells in Military Facilities

United States Naval Support Unit (NSU) – Saratoga Springs, NY

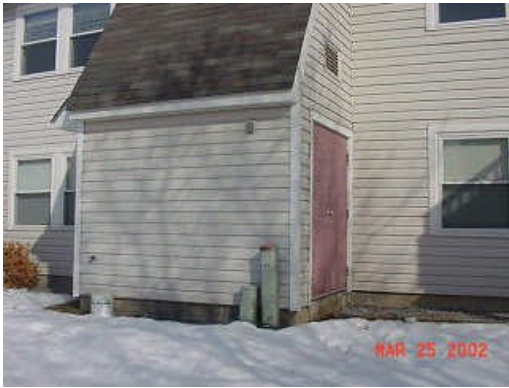
Fig. 1

During the site selection phase (Spring 2002), the main concerns were with location of utility connections and logistics for shipping, rigging and construction. A typical site/mechanical room serving one of the townhouse buildings is shown in Figures 1 and 2. The natural gas, communications, electrical equipment and water supply are all readily accessible. Clearance for rigging was more than adequate and space for the crew to work was generous.

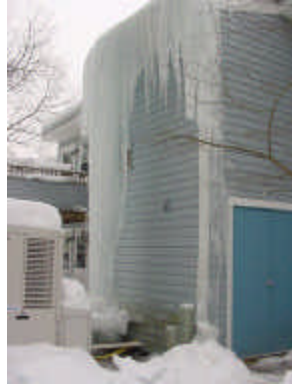
Fig. 3

Additionally, the severe winter of 2003 amplified certain site characteristics that otherwise would not have been a concern. The primary issues with the NSU sites were: ice formation on the roof above the systems (Fig 3) and the lack of winter accessibility due to snow build-up (Fig 4).

According to site personnel, this level of ice formation and snow build-up has never occurred before. While that may be true, it is incumbent that site planning address this type of issue for future installations. The result could have been serious had one of the large ice pieces fallen on a Technician or an energized gas line.

To protect against mechanical damage, Plug Power fabricated wooden covers for the pipes. These covers can be seen in the completed site photographs below. For future installations, certain questions must be answered as part of the site selection process. For example:
